***Appendix III: Historic Preservation Letters***

Re: Lee Shopping Center, N Pershing Drive

RETAIL FACADE DETAILS - PROPOSED PROJECT

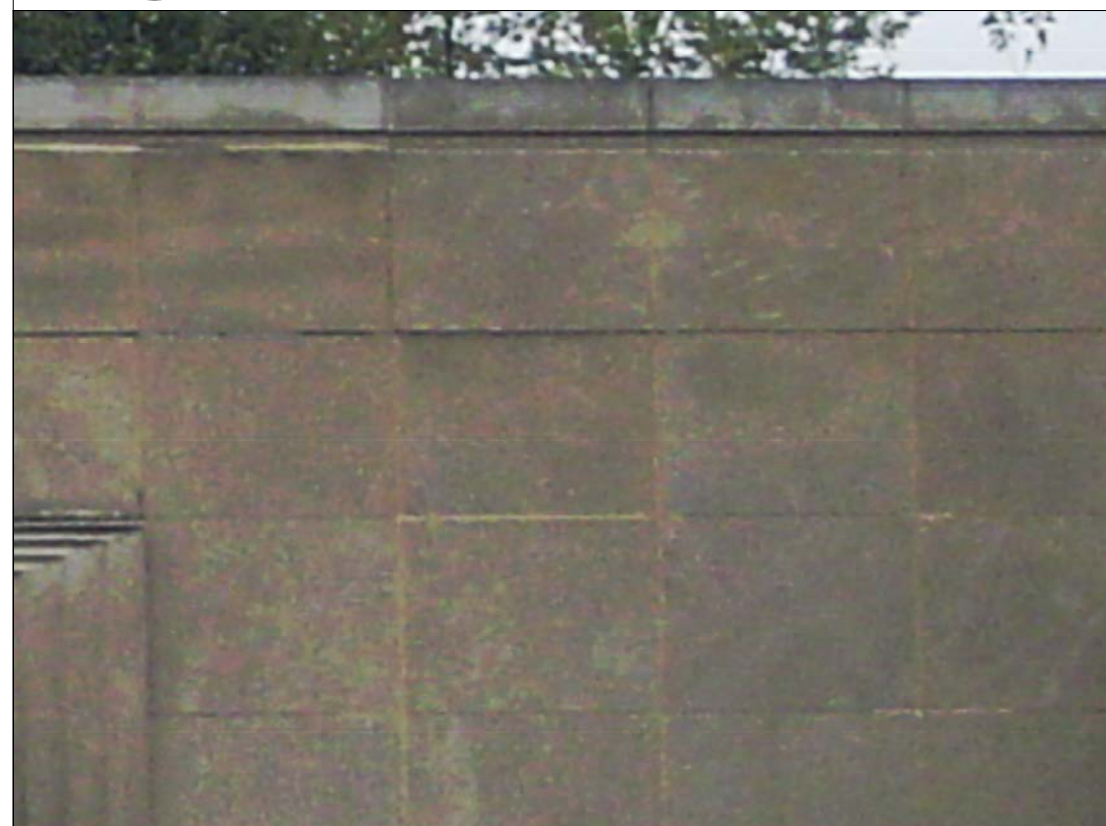
1 RECTANGULAR PATTERN

The areas above the existing storefronts feature a rectangular joint pattern between the concrete panels. In the areas where the retail base of the proposed buildings is extended beyond the line of the residential above, we have again incorporated this joint pattern into the configuration of the cast stone base.

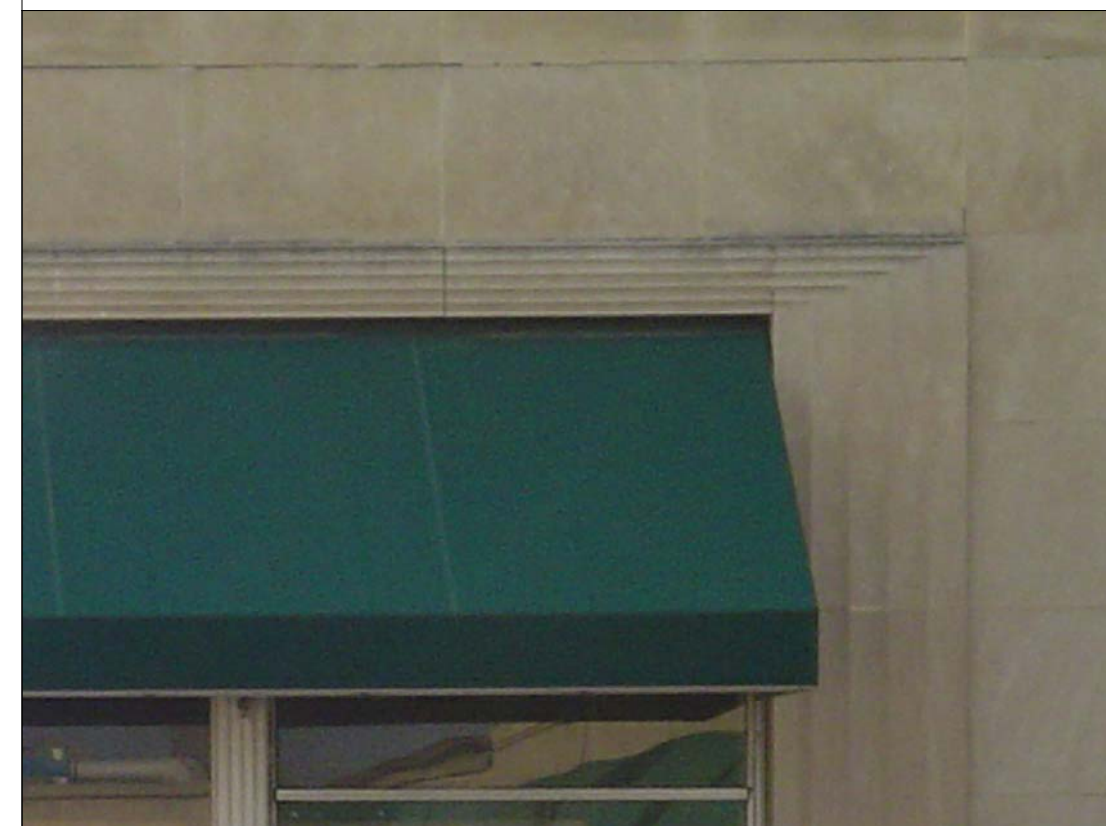
2 ACCENT MOLDING

In select locations, the existing building features a streamline art deco fluting pattern immediately above the fabric awnings and running both horizontally across the top of the storefront glass and vertically down one side. We have a similar detail with textured block in these areas

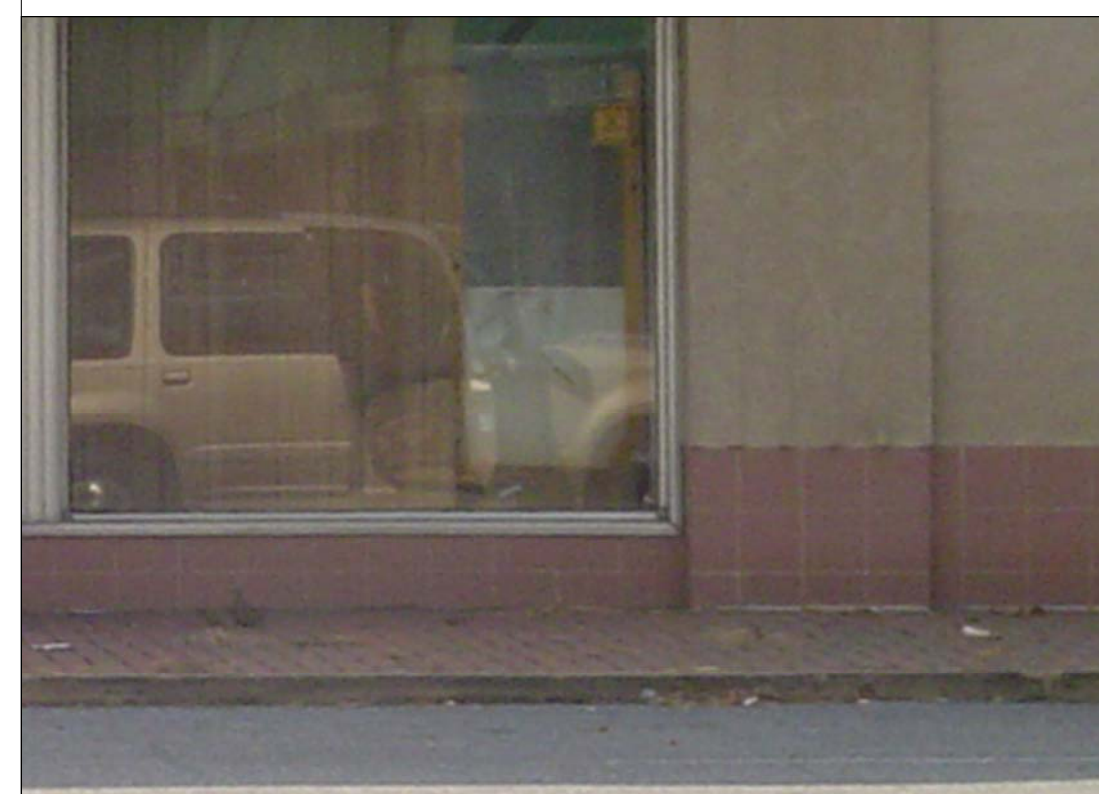
3 WATER TABLE

Lee Center has a low water table tile element at the base of the existing concrete piers and under some of the storefront glass. While it is not clear whether this base tile was actually part of the original design of the Lee Center or whether it was added later, we have included a similar detail with a base of precast concrete in similar square patterning.
